1. Project Name: Rota SBH
2. Date of Inspection: June 6, 2002
3. Inspection Personnel:

Revetted Mole - 535 LF:

ROTA HARBOR, NORTHERN MARIANAS

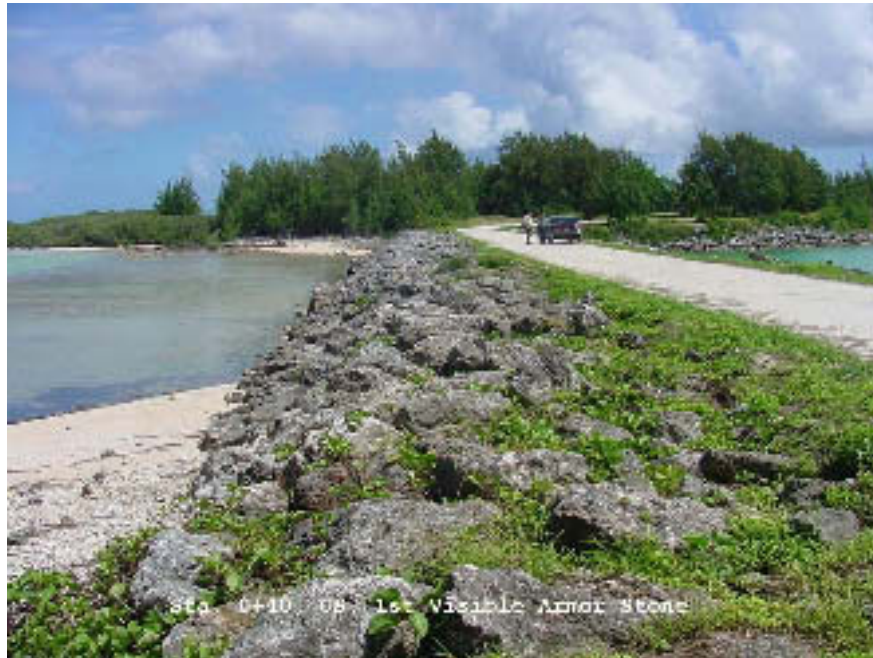
- a. Sta. 0+00, Oceanside (OS), 1st visible sign of armor stone.

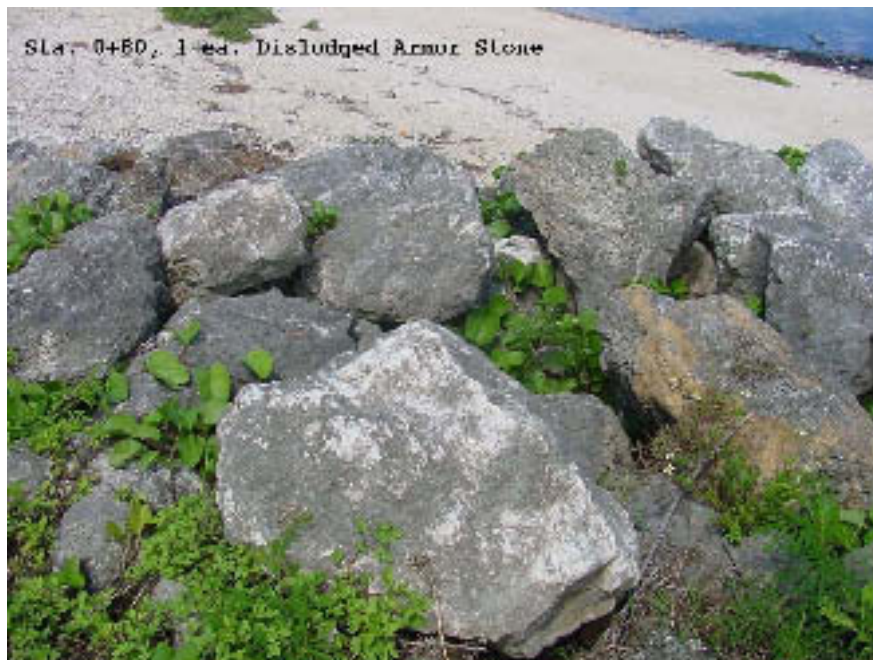
- b. Sta. 0+80, OS, 1 ea. dislodged armor stone and void.

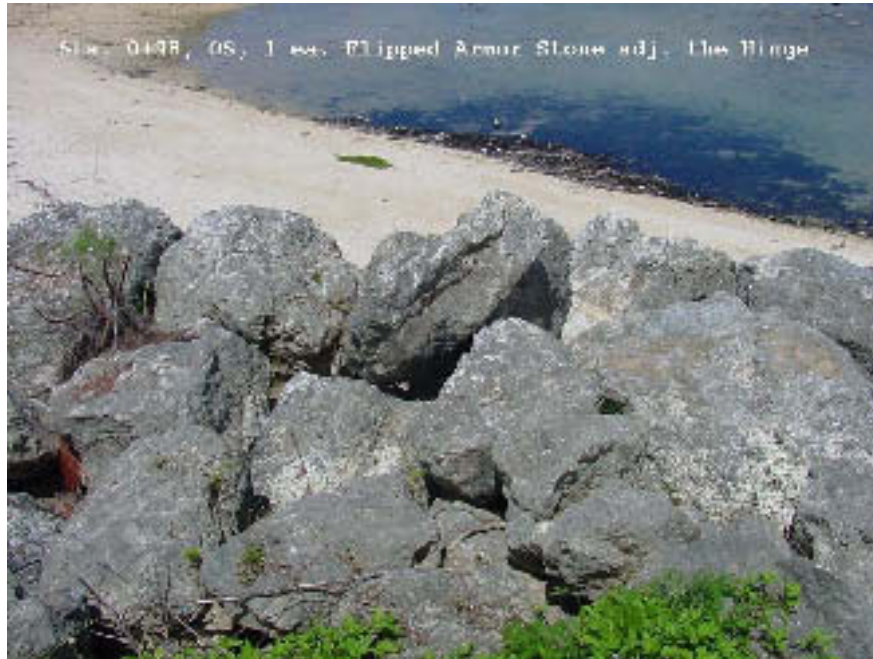
c. Sta. 0+98, OS, 1 ea. flipped armor stone.

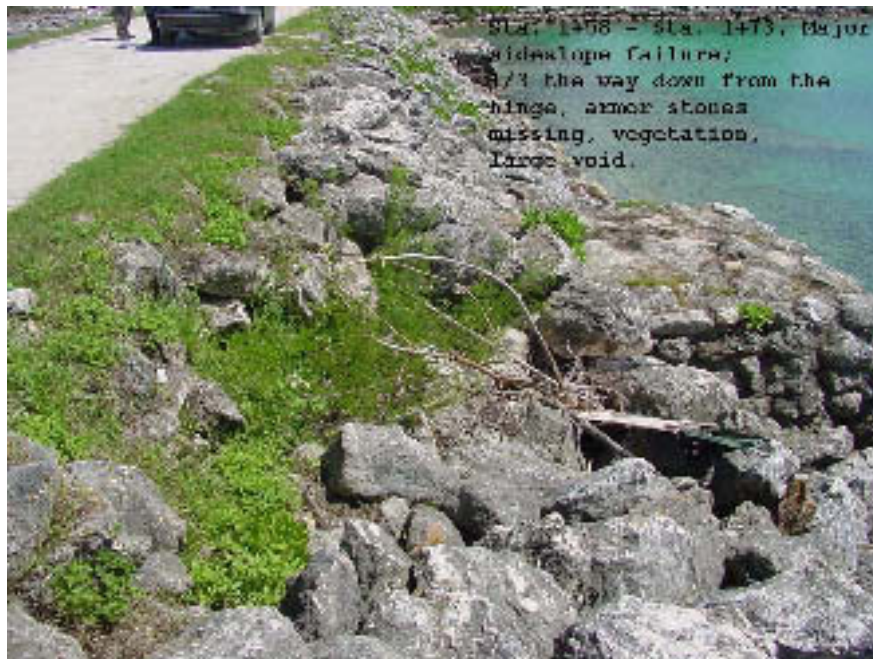
The Revetted mole is approximately 535 LF. The overall condition of the project is fair. There has been some on-going deterioration, at Sta. 1+80, (1st. Set of Culverts) which has progressed to a point where repairs are required to ensure the continuing functionality of the structure.

d. Sta. 1+58 to Sta. 1+73, HS, Potential Breach Area, missing armor stones and void approx. 1/3 of the sideslope.

Ben Manglona, CPA stated that there was a build-up of silt material in the north-east corner of the turning basin adjacent to dock # 1. Repairs and vegetation removal should be programmed for as soon as possible.

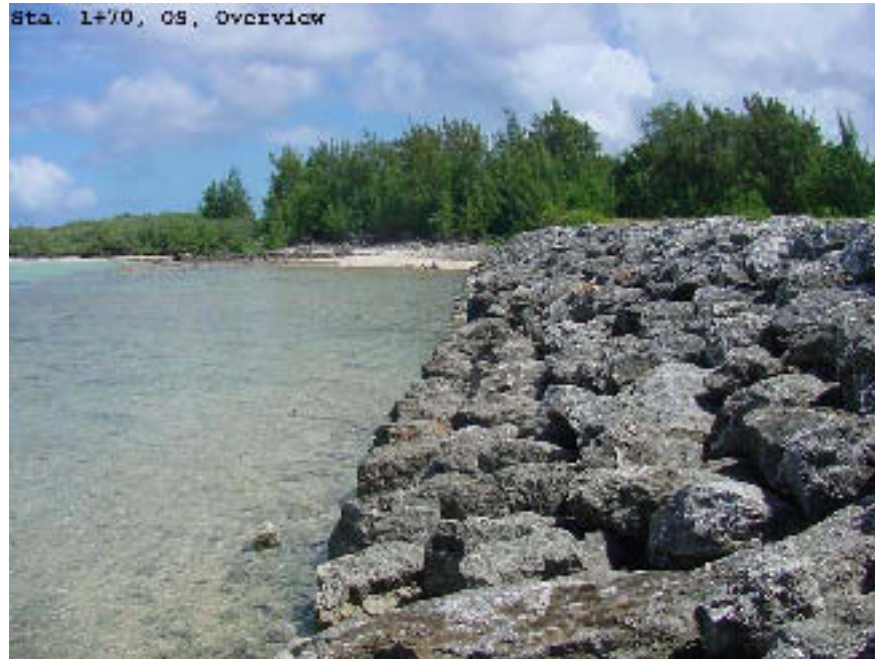
e. Sta. 1+70, OS, Overview (reference photo).

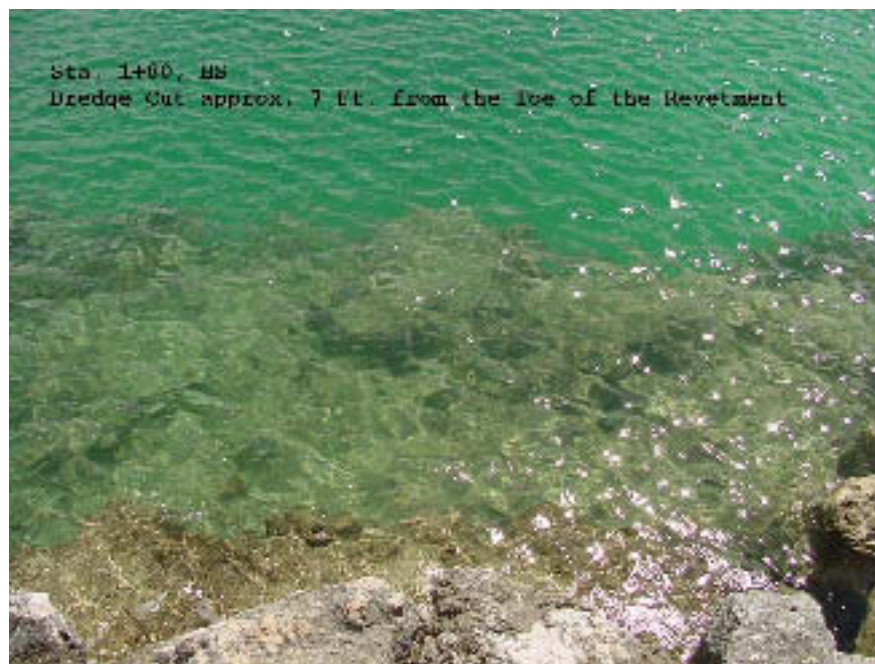
f. Sta. 1+80, Harborside (HS), Dredge cut approximately 7' from toe of the structure (reference photo).

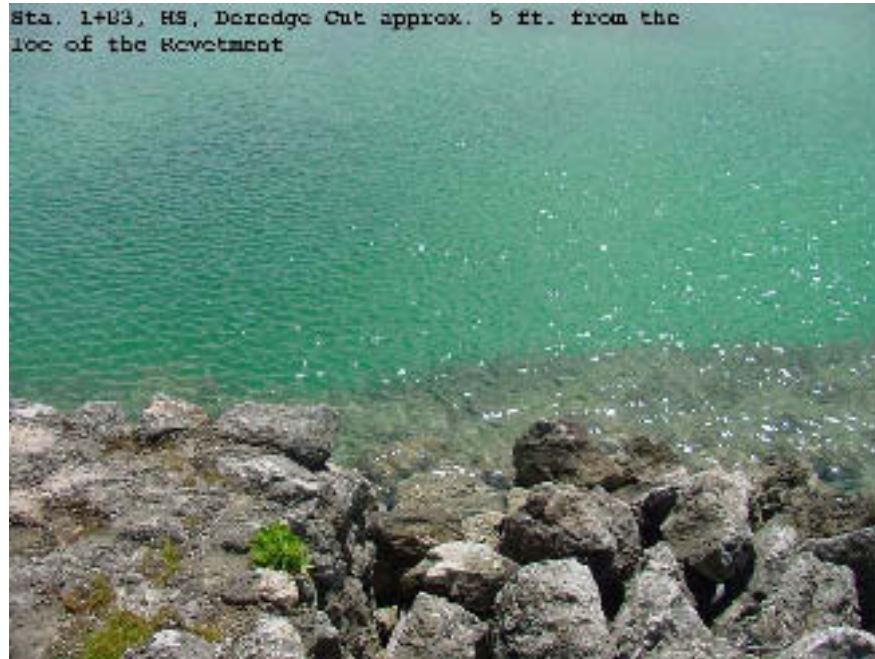
g. Sta. 1+83, HS, Dredge cut approximately 5' from toe of the structure (reference photo).

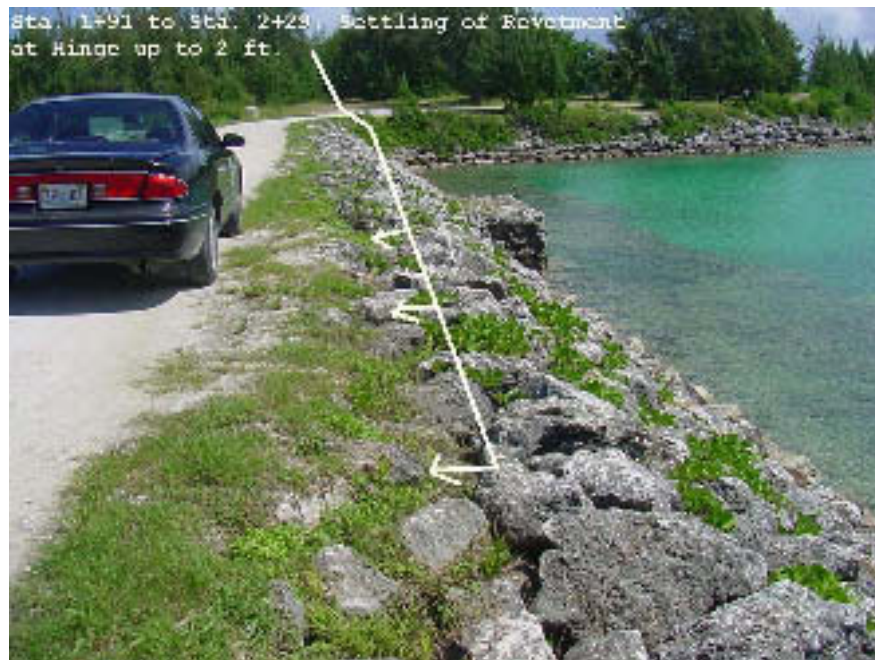
h. Sta. 1+91 to Sta. 2+29, HS, Settling of the hinge up to 2'.

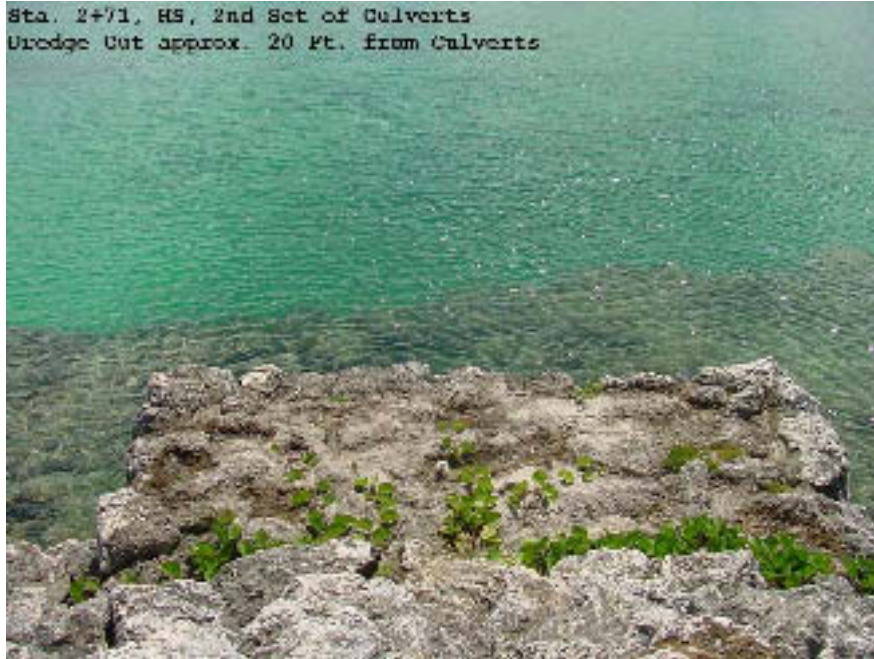
Sta. 2+71, HS, 2nd Set of Culverts
Dredge Cut approx. 20 Ft. from Culverts

- i. Sta. 2+71, HS, dredge cut approx. 20' from culverts (reference photo).

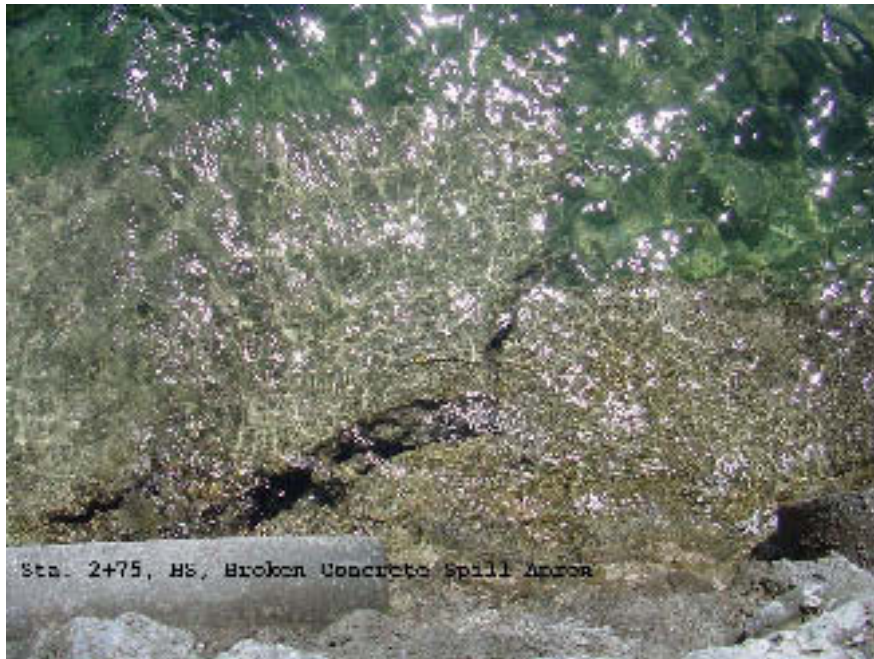
Sta. 2+75, HS, Broken Concrete Spill Apron

- j. Sta. 2+75, HS, broken concrete spill apron.

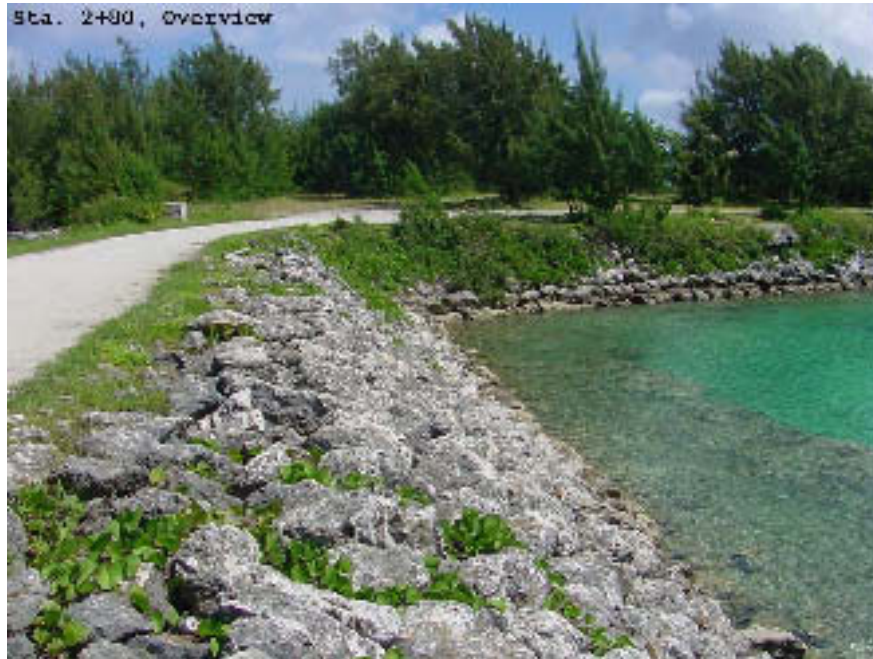
k. Sta. 2+80, HS, Overview, (reference photo).

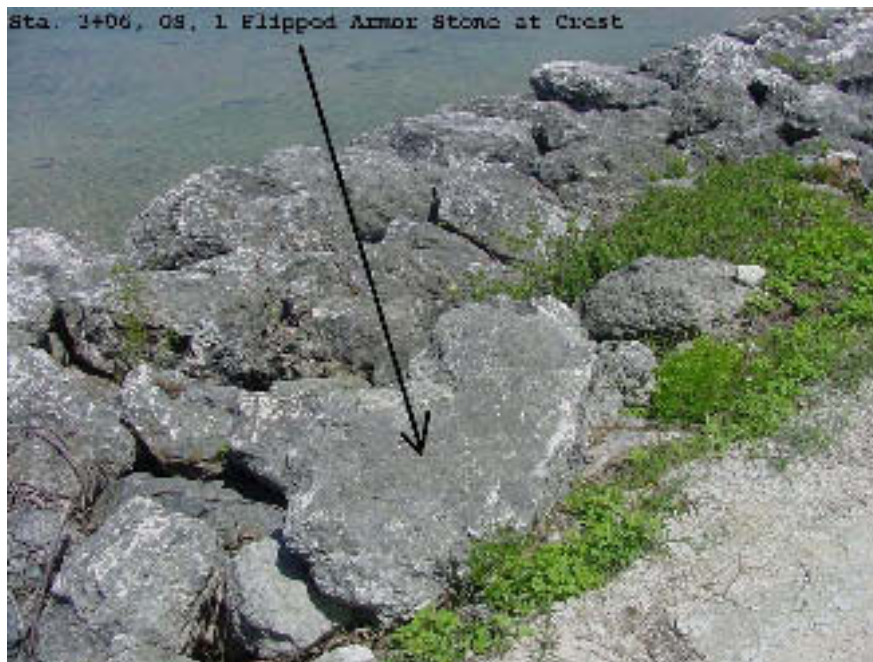
l. Sta. 3+06, OS, 1 ea. flipped armor stone at crest.

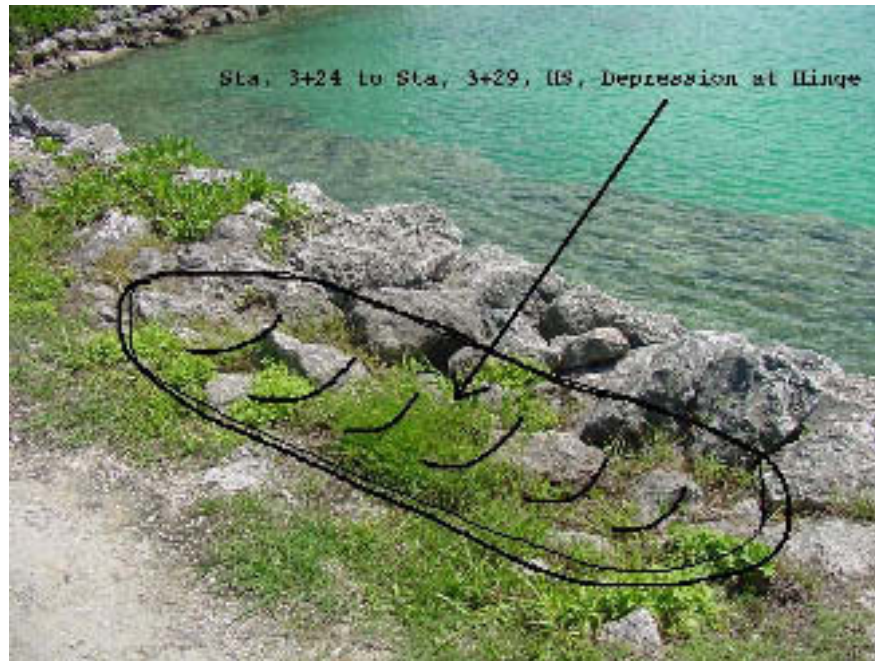
m. Sta. 3+24, HS, Settling / depression at hinge of sideslope.

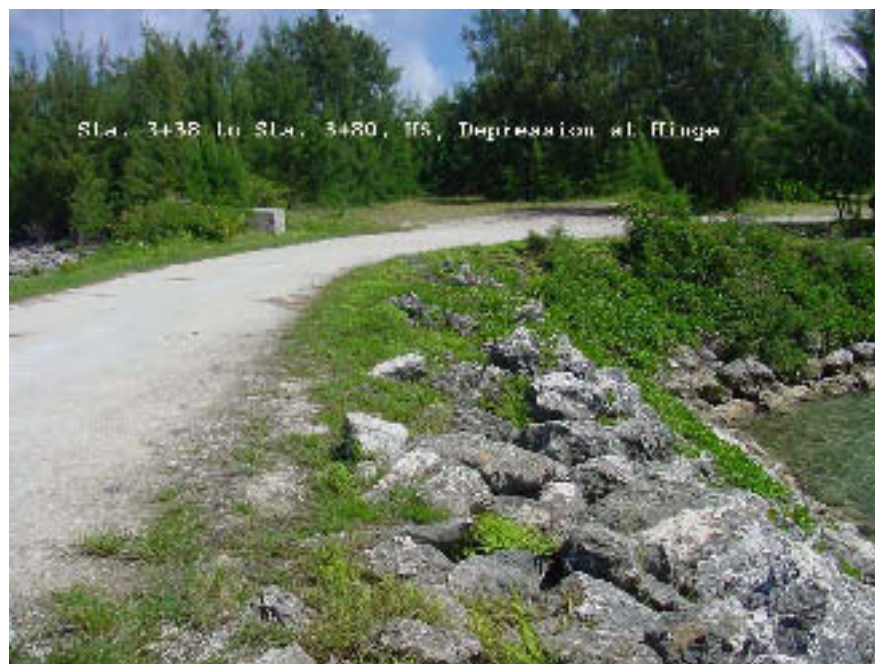
n. Sta. 3+38 to 3+80, HS, Settling / depression at hinge of sideslope.

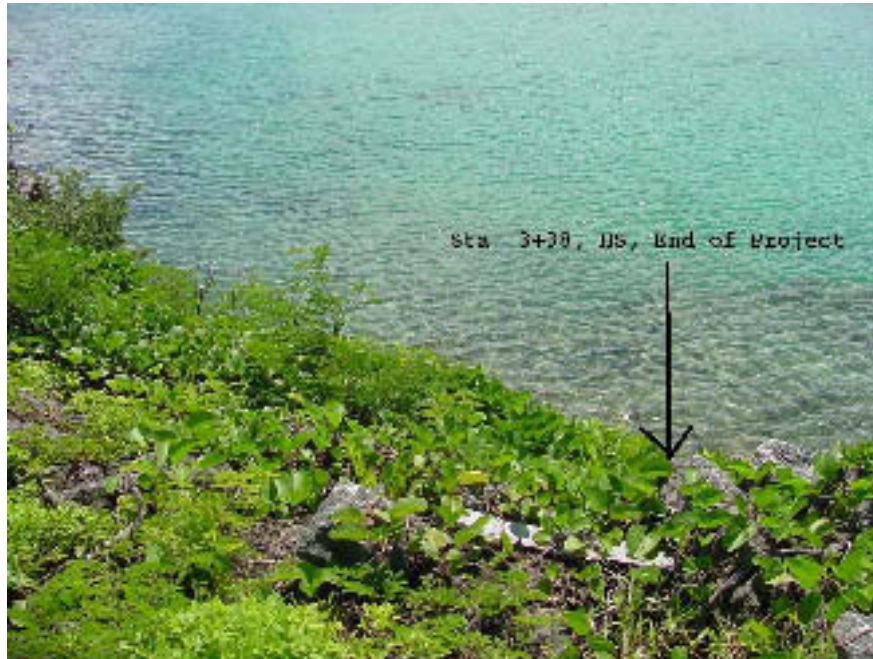
- o. Sta. 3+38, HS, end of revetment (reference photo).

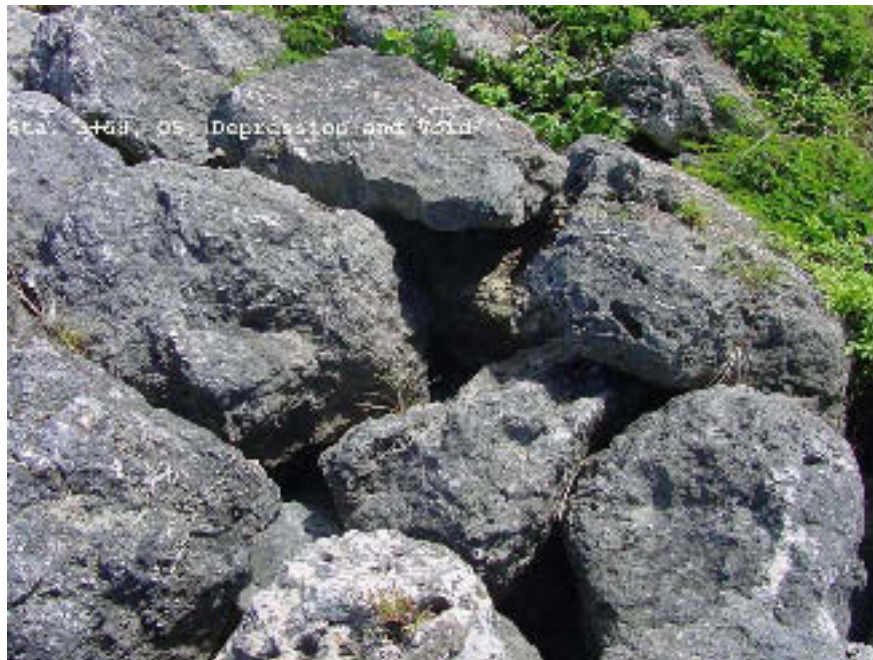
- p. Sta. 3+68, OS, slight depression and void near crest on sideslope.

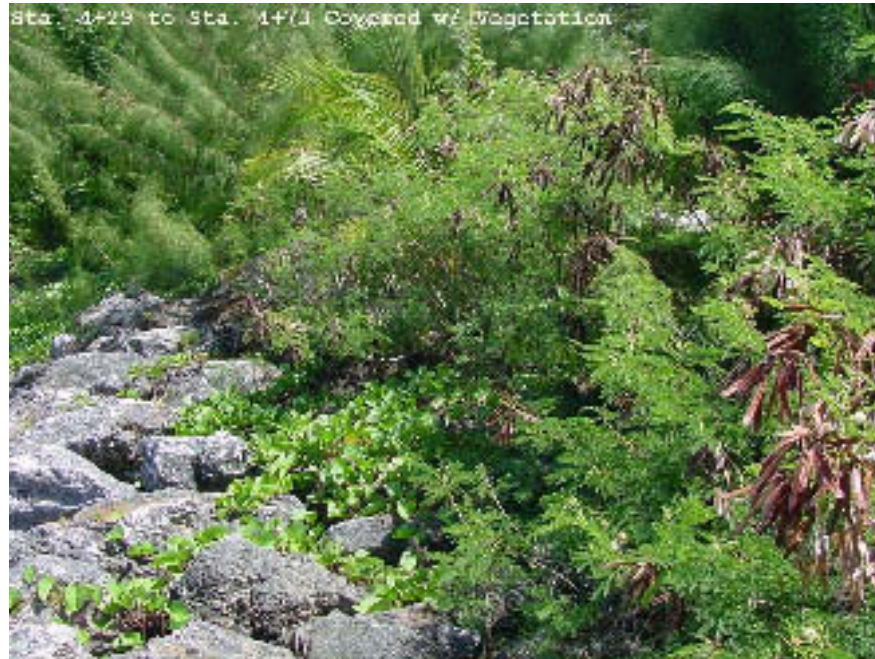
q. Sta. 4+29 to Sta. 4+73, OS, Covered with vegetation.

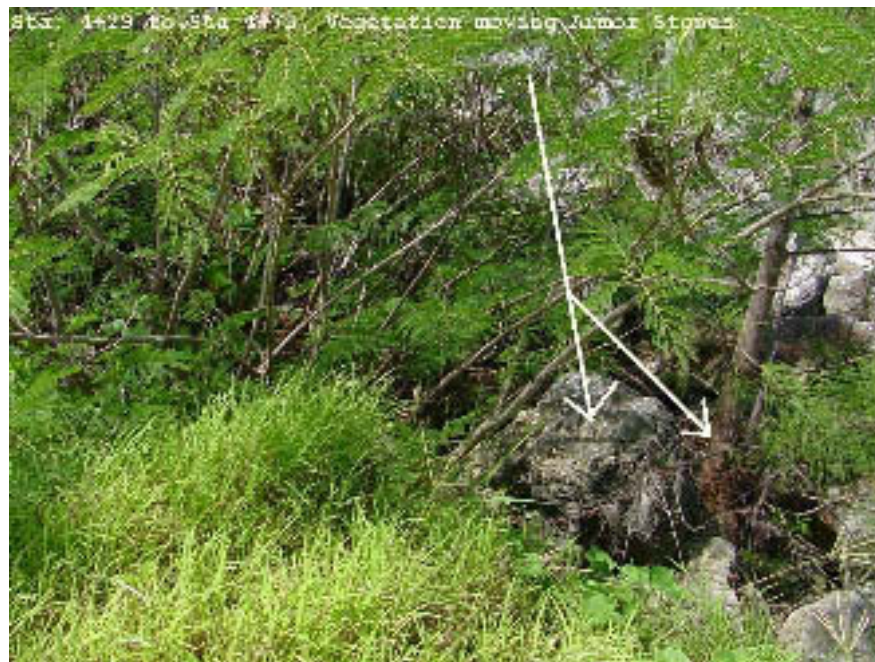
r. Sta. 4+73, OS, Ironwood tree displacing armor stone on the sideslope.

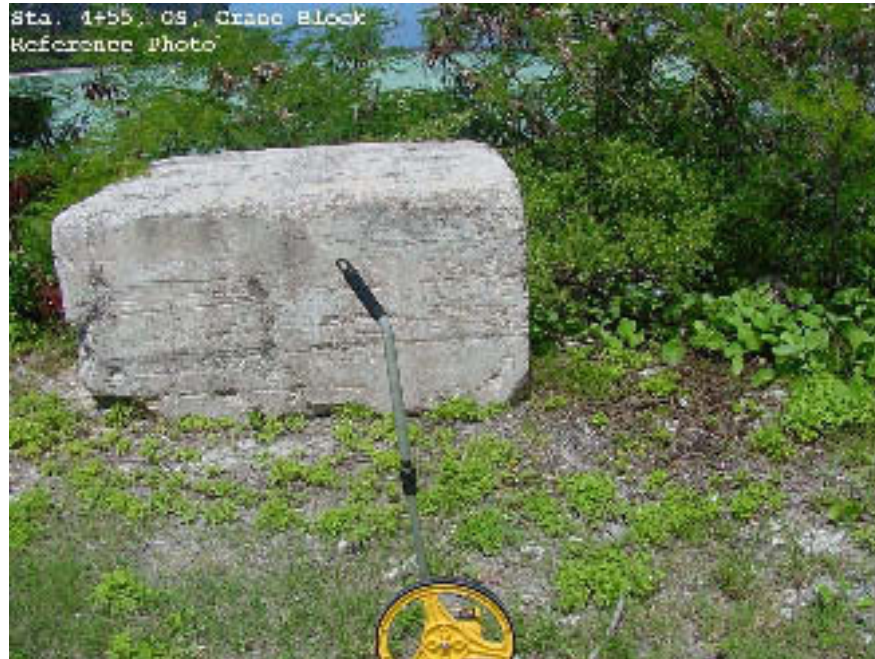
s. Sta. 4+55, OS, (reference photo).
